January 9, 2015

**RE: ASSESSMENT OF WATERSHED MANAGEMENT IN CH1, MF360 CHAPMAN CREEK**

Gordon Butt, M.Sc., P.Ag., P.Geo. Professional Geoscientist

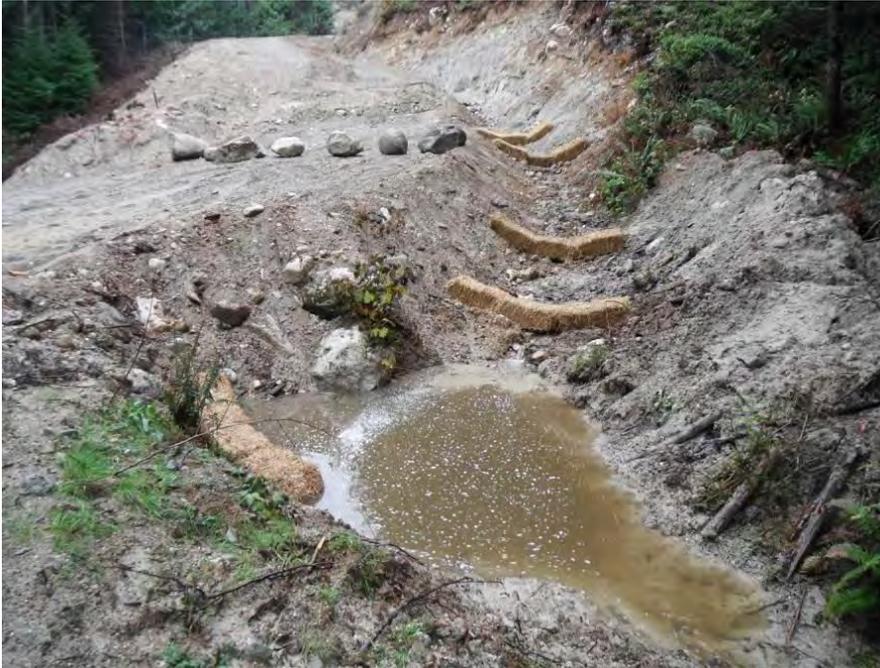
The unstable cutslope, running surface and large ditch has resulted in obvious signs of sedimentation, with turbid water from the ditch emptying into an intake pond above the culvert under the FSR. This pond has intercepted a portion of the fine sands and silts, but

I understand that heavy rains occurred in early October and at that time the road was in active use. As a result, the junction of the FSR and Spur 1 was covered in mud. In response, AJB directed the contractor to upgrade sediment control measures, including installation of additional hay bales and silt fences. These have had marginal effectiveness with most water flowing under the hay bales or around the silt fences.

**Photo 1.** Intake pond at junction of FSR and Spur 1. The hay bales have marginal effectiveness since ditch water flows underneath them. The intake pond in the foreground is reasonably effective in settling out coarse sediment such as sand and possibly a part of the silt fraction.

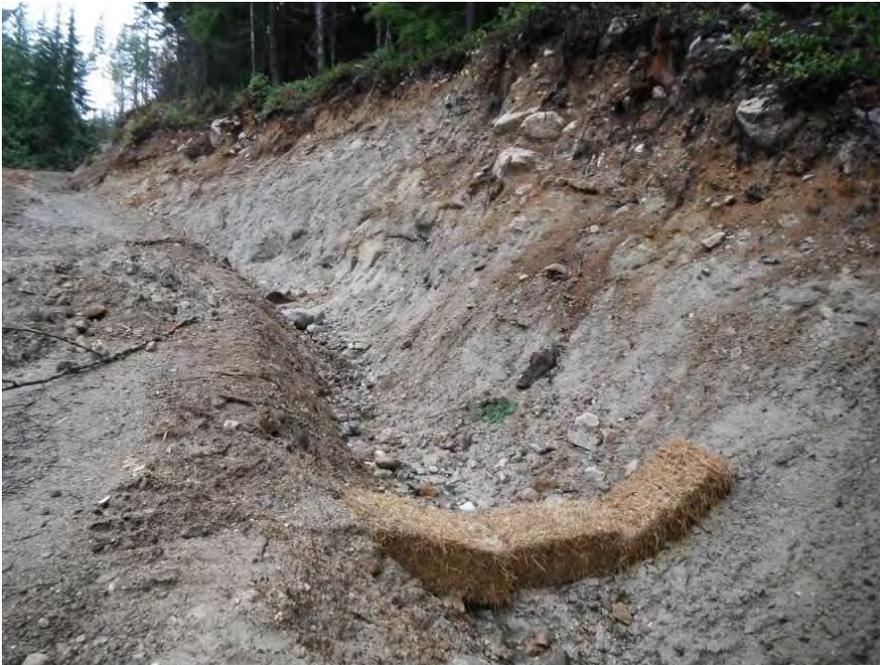
Spur 1 is a conventional cut and fill logging road built with steep (15%) grades through deep glacial deposits, with deep and locally unstable cutslopes (Photo 1). The grades are such that it is difficult to avoid erosion and sedimentation from the running surfaces, cutslopes and ditches (Photo 2). The road grade becomes gentler after about 100 m. There is a culvert for Stream "E" which appears to be sufficiently large for the discharge, but unfortunately is too short for the road (or the road is too wide) so that there has been some erosion of the fillslope above the outlet (Photo 3). This introduced sediment was transported downstream.

**Photo 2.** Large unstable cuts in Spur 1. A significant sediment source, however this road was originally built in the 1990s and so it is in part a 'legacy' problem. It should have been seeded to an erosion control mixture shortly after reconstruction.

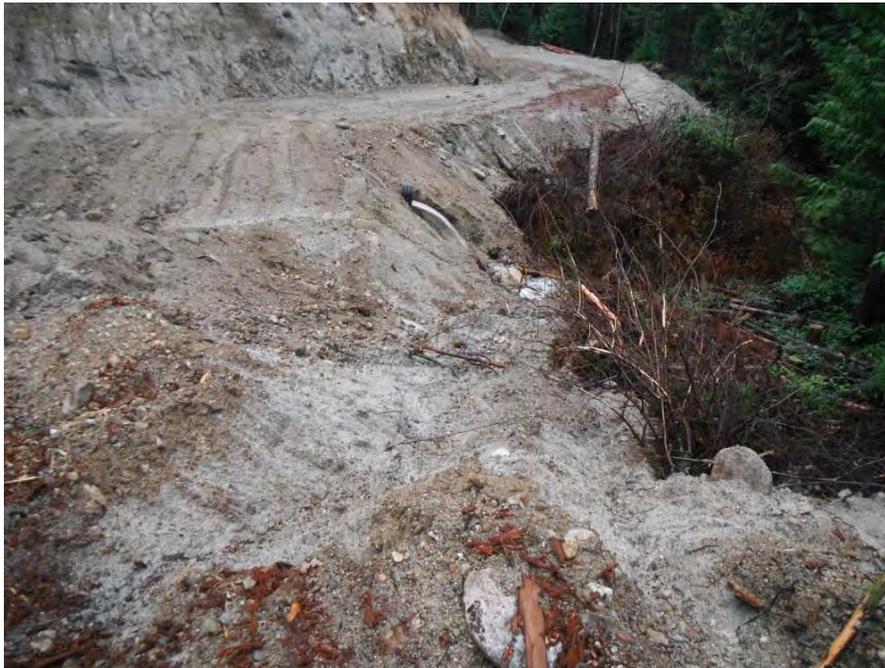
**Photo 3.** Spur 1 looking down-grade. The pipe is too short (or road too wide) and fillslope has eroded. Note water bar this side of the culvert that drains Stream 'E'.

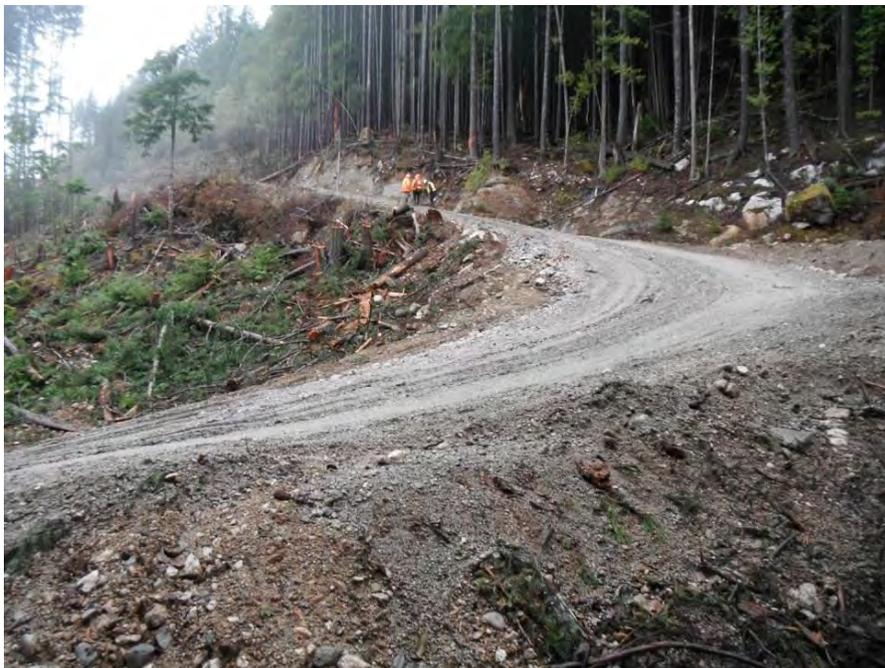
Like Spur 1, this road climbs steeply off the FSR switch-backing up with grades of up to 27% (Photo 4). Ditch water is discharged down to the FSR then under the beginning of Spur 5 via a small plastic corrugated culvert and into the ditch alongside the FSR, ultimately to flow into a culvert and down to Chapman Creek. Unfortunately, this additional water from Spur 5 threatened to overload the ditch which would then flow onto the running surface of the FSR, potentially eroding it.

The steep grade of the road was also a source of sediment, especially during and immediately after active logging. The surface had experienced rill and sheet erosion. The steep pitches should be seasonally deactivated with water bars and/or cross-drains but at the time of my assessment logging had not been completed.

**Photo 4.** Spur 5 climbs steeply above the FSR. The steep grade has been subject to sheet wash and rill erosion and the ditch water was diverted into the FSR ditch, possibly overloading it.

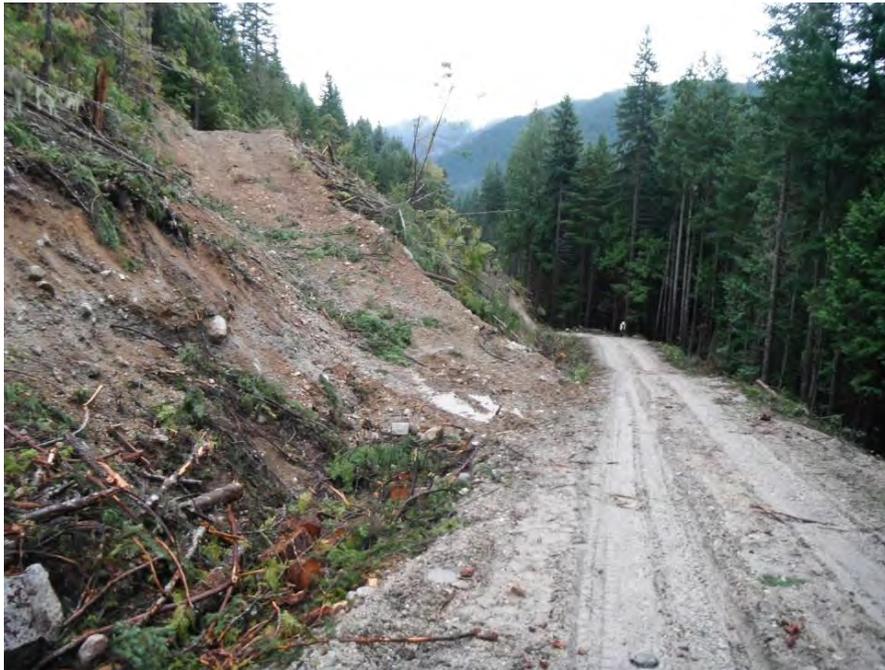
In several locations along Spur 5 the contractor had developed machine access roads (bladed roads not trails) off the spur road to access wood above the road (Photo 5). Since no culverts were installed where the roads left the spur road they blocked ditch flow, forcing it to flow onto the surface, which, after machine traffic, left ruts and an eroded surface.

**Photo 5.** Spur 5 and machine access trail to left. No water management on the steep trail and no culvert allowing ditch water to drain.

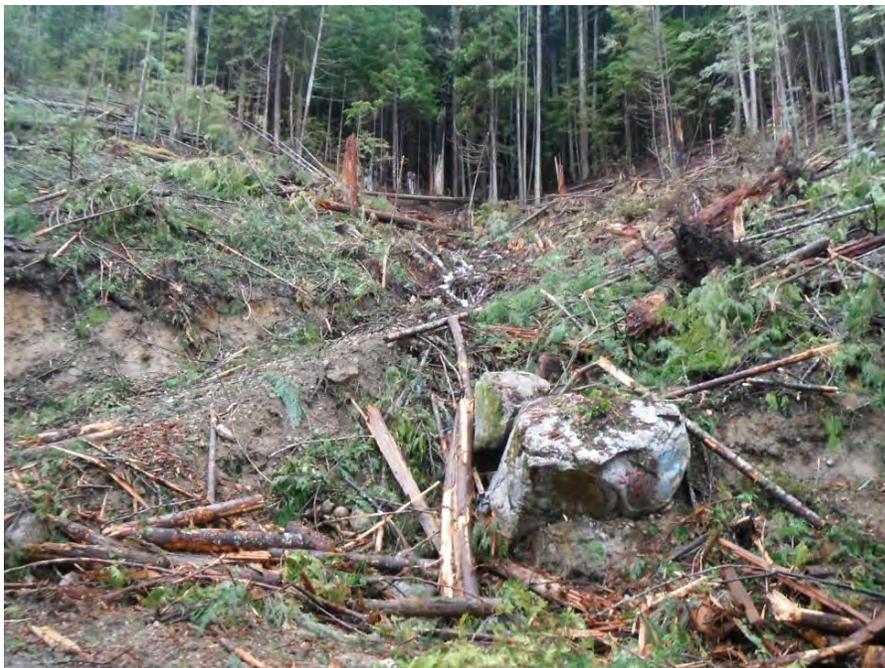
I also noted that two of the machine access roads climbed above the Spur in swales subject to seasonal flow (Photo 6) and in at least one case up a small stream (not Class E). These locations were chosen because they were the best routes for access to gentler slopes above. However, the result is that when heavy rains occurred in October erosion developed creating an unsightly image (Photos 7 and 8).

**Photo 6.** Machine trail up a swale from Spur 5. It has no diverted surface flow. It was probably dry at the time of logging, but trails should not be placed on watercourses.

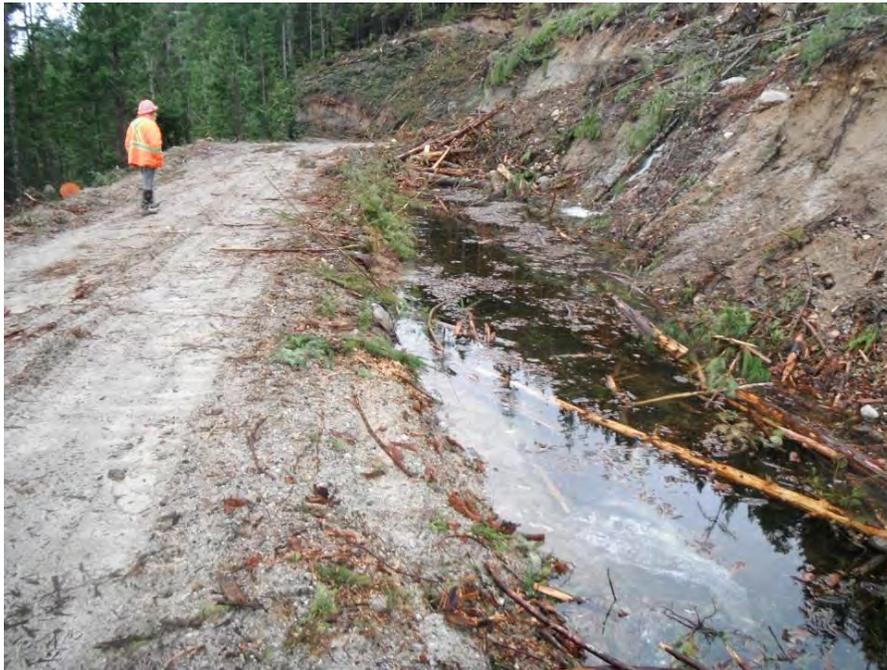
**Photo 7.** Spur 5. Water ponded in ditch between two machine access trail. These trails should be put to bed immediately after use.

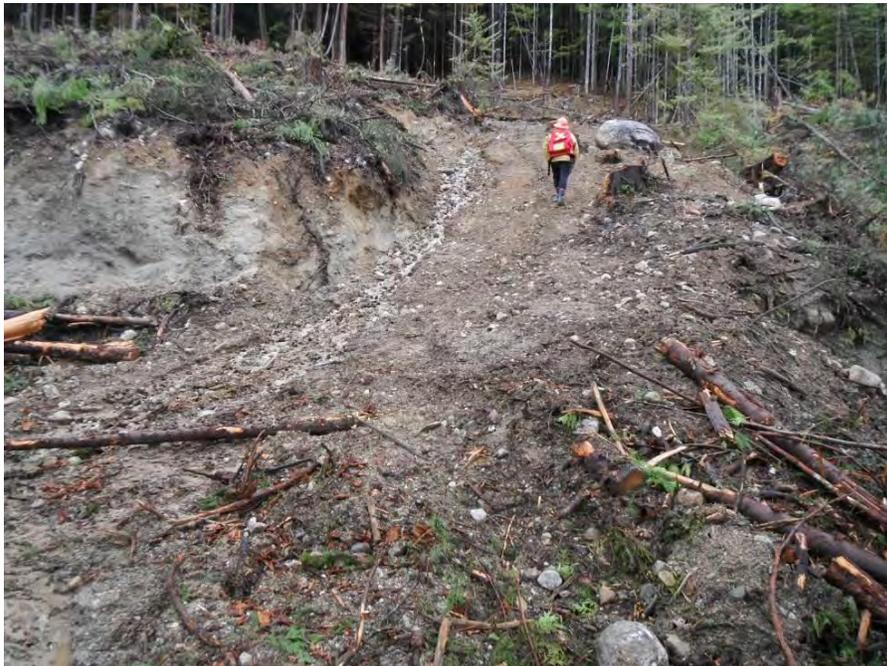
**Photo 8.** Rill erosion down machine access trail, off Spur 5.

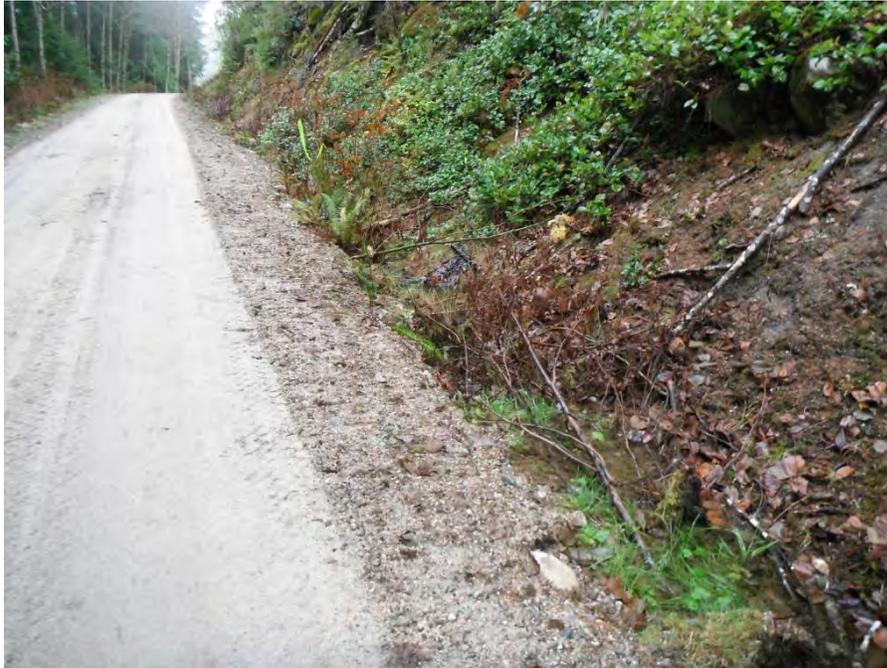
At the time of my assessment, despite recent heavy rain, the road prism itself was in good condition, with a crowned surface and no grader berms on the downslope side. There was evidence of cutslope slumping into the ditch, almost all of which occurred decades ago (Photo 9). I saw no evidence of recent instability.

**Photo 9.** FSR. The road is well crowned with no grader berm, but the old ditch is ineffective due to soil slumping in over the decades. Given the amount of rain, the ditch should have been cleaned in the dry season and pipes replaced as needed.

Prior to logging, the decision was made not to clean the ditches along the FSR downslope of Block CH1. This decision was taken due to legitimate concerns that cleaning would result in increased sediment delivery to Chapman Creek. However, after heavy fall rains it was clear to me that the ditch was inadequate to convey the amount of water and in several locations there was a risk of overflow from the ditch onto the road running surface. After having seen this I would suggest cleaning the ditch next year under dry conditions.

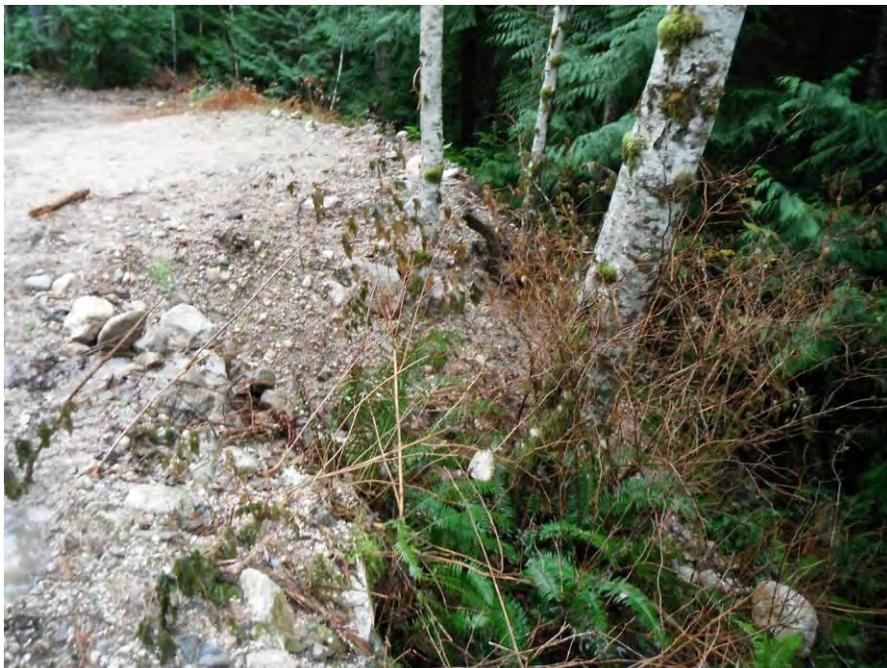
Near Stream "B" the contractor expanded an existing turn-out, pushing earth towards the stream channel on the downside (right) of the road (Photo 10). This is an opportunity for direct delivery of sediment into the stream. This should be pulled back as soon as possible when the weather dries out.

**Photo 10.** Existing turn-out on FSR was expanded by pushing earth out. Stream channel is immediate to right and flows directly to Chapman Creek.

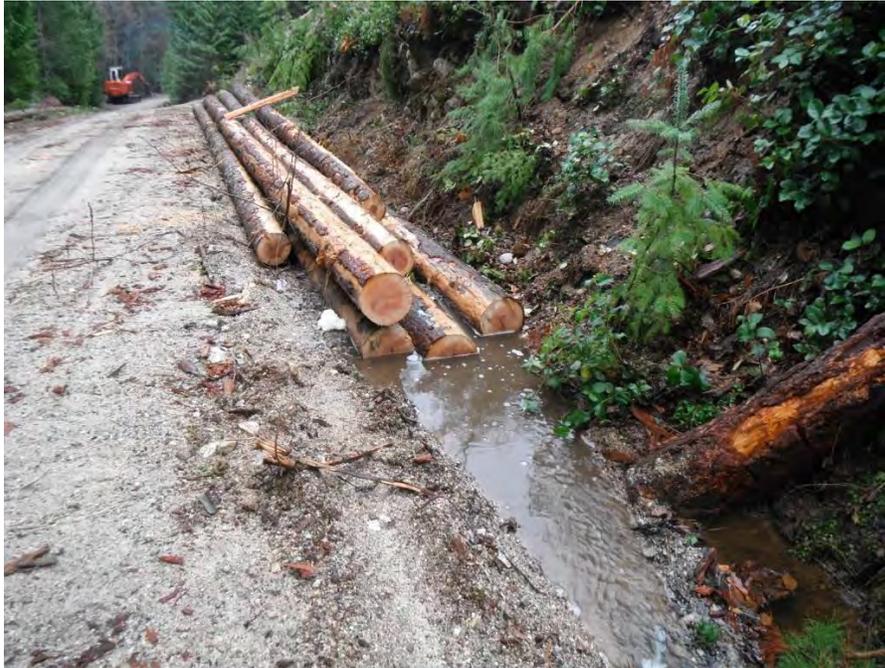
Another factor affecting road drainage is the practice of decking logs in the ditch (Photo 11). This diverts water onto the road and softens it, leading to sedimentation after vehicle use.

**Photo 11.** Logs decked in ditch. This impairs the function of the drainage system on a road directly upslope of the Chapman Creek mainstem. This should not happen in a sensitive watershed providing drinking water.
