Cutblock 883256 (Lot 450) Inspection Powell River

Cutblock 883256 Inspection

Inspection # IN-1501

July 15, 2015

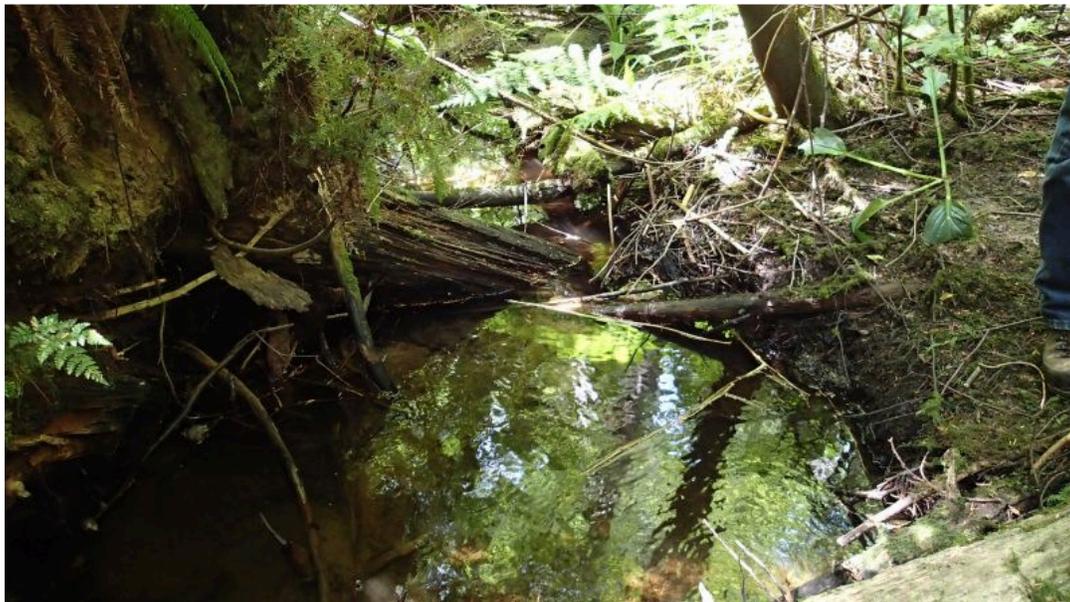
The classifications of the three streams was reviewed in the field. McGuffie Creek is identified as a Class C stream on Island Timberland's Logging Plan map. A Class C stream is a fish stream that has a channel width greater than 1.5 m but less than 3.0 m. Juvenile salmonids, possibly trout, were observed at waypoint 564 (photo 1) confirming the presence of fish. The stream channel width was measured at six locations at waypoint 564 (Figure 3) and the average channel width was 2.1 m. Class C is therefore the correct classification.

Photo 1 McGuffie Creek at waypoint 564. Average channel width is 2.1 m.

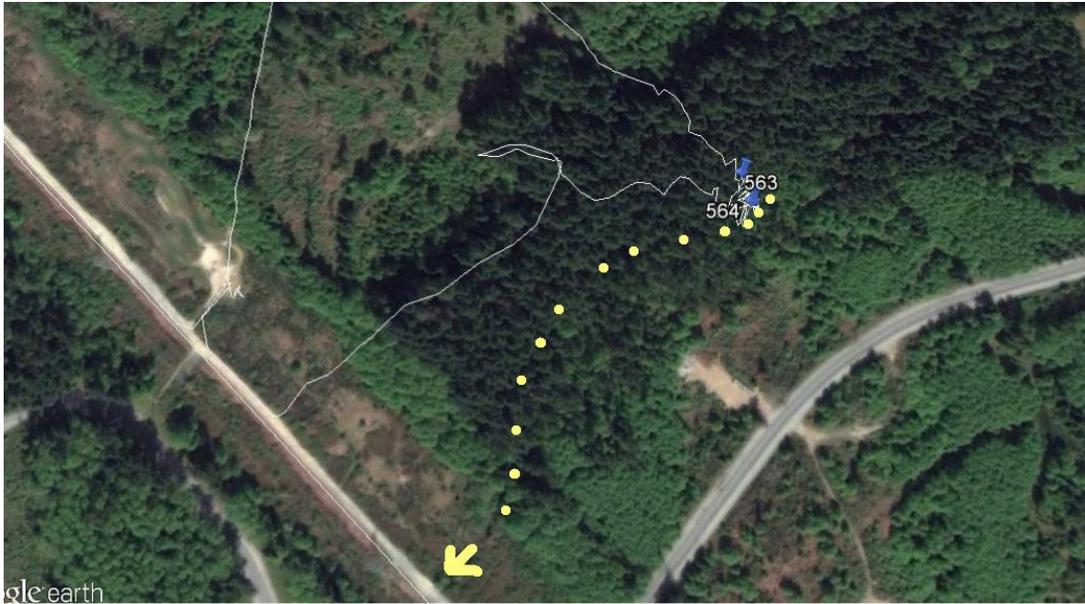
Figure 3 Google Earth image of the portion of cutblock 883256 with McGuffie Creek (yellow dotted line). The Creek was inspected at waypoint 564.

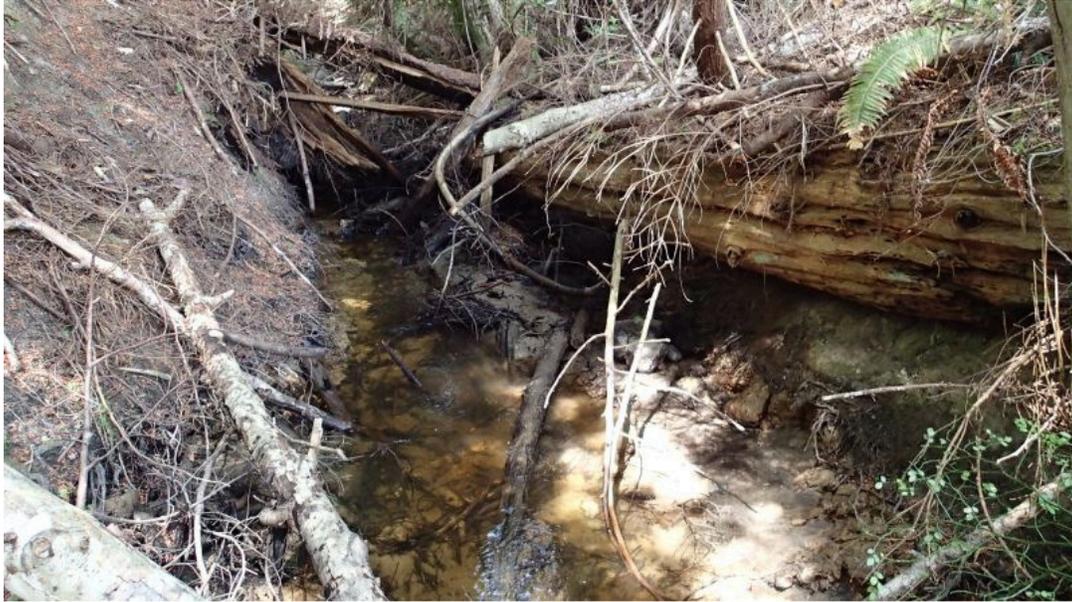
McFall Creek is identified as a Class B stream on Island Timberland's Logging Plan map. A Class B stream is a fish stream that has a channel width greater than 3.0 m but less than 10.0 m. Numerous coho salmon juveniles were observed at waypoints 565 and 567 (Figure 4) confirming that this watercourse is fish bearing. The stream channel width was measured at six locations at waypoint 565 (Figure 3) and at three locations at waypoint 567. The average channel widths at waypoints 565 and 567 were 2.5 m. (photo 2) and 3.3 m. (photo 3) respectively. Class B is therefore the correct classification.

Photo 2 McFall Creek at waypoint 565. Average channel width is 2.5 m.

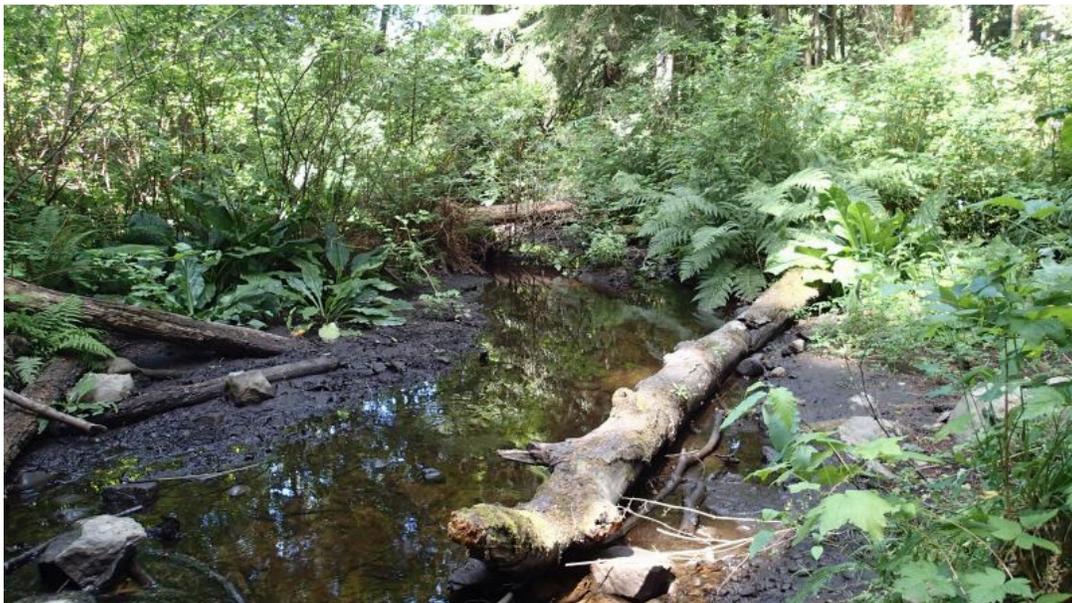
Photo 3 McFall Creek at waypoint 567. Average channel width is 3.3 m.

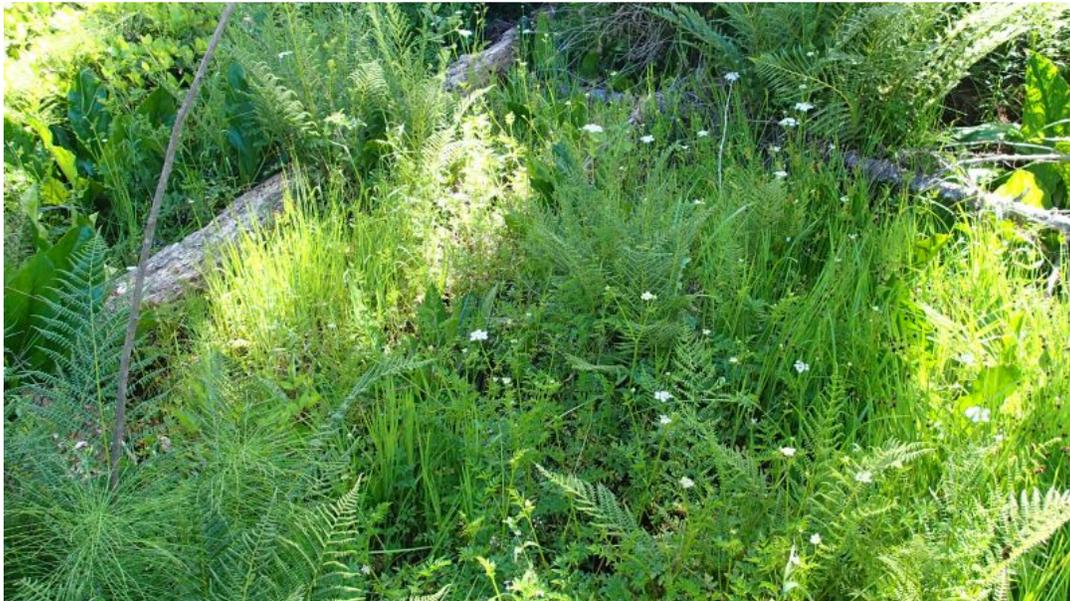
Wys Creek at waypoint 569 is identified as Class E and as a NCD at waypoint 572 on the Logging Plan Map. Wys Creek had no defined channel at waypoint 569 (photo 4) so a stream Class E designation is

Photo 4 Wys Creek at waypoint 569. No scoured channel visible.

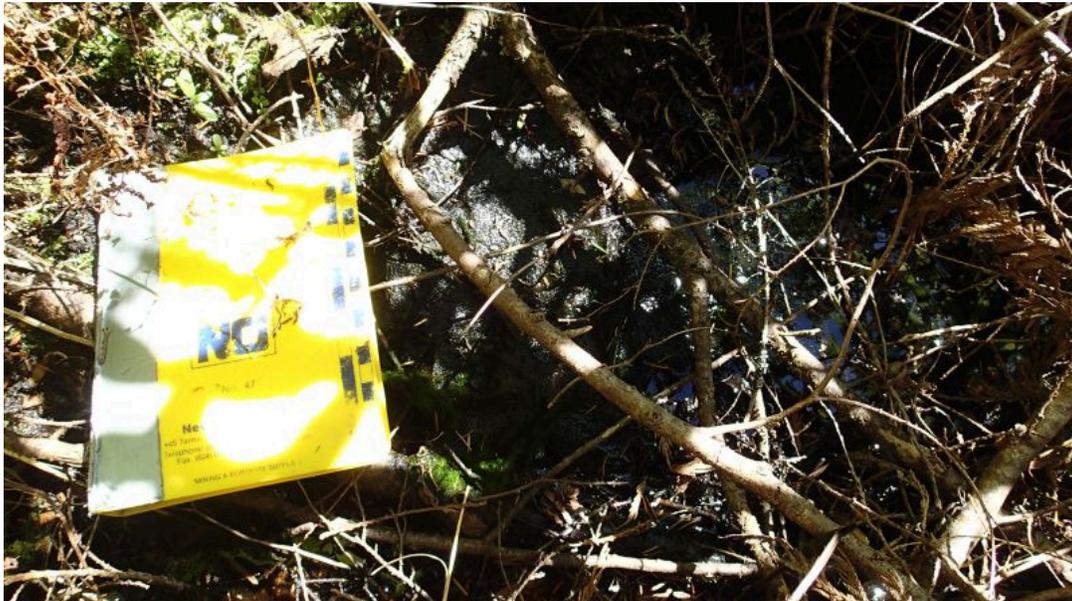
conservative, at least for this location, and could have been classified as an NCD. Wys Creek at waypoint 572 (photo 5) also lacked a continuously defined channel and meets the definition of a NCD. Wys Creek at the first crossing (waypoint 568) had an average channel width of less than 1.5 m so is technically not Class E (Class E stream is wider than 1.5 m). It is concluded that the classifications of Class E and NCD for the portion of Wys Creek within active (2015) forest harvesting areas and at the first road crossing are appropriate and may be conservative.

Photo 5 Wys Creek at waypoint 572. No defined channel visible.

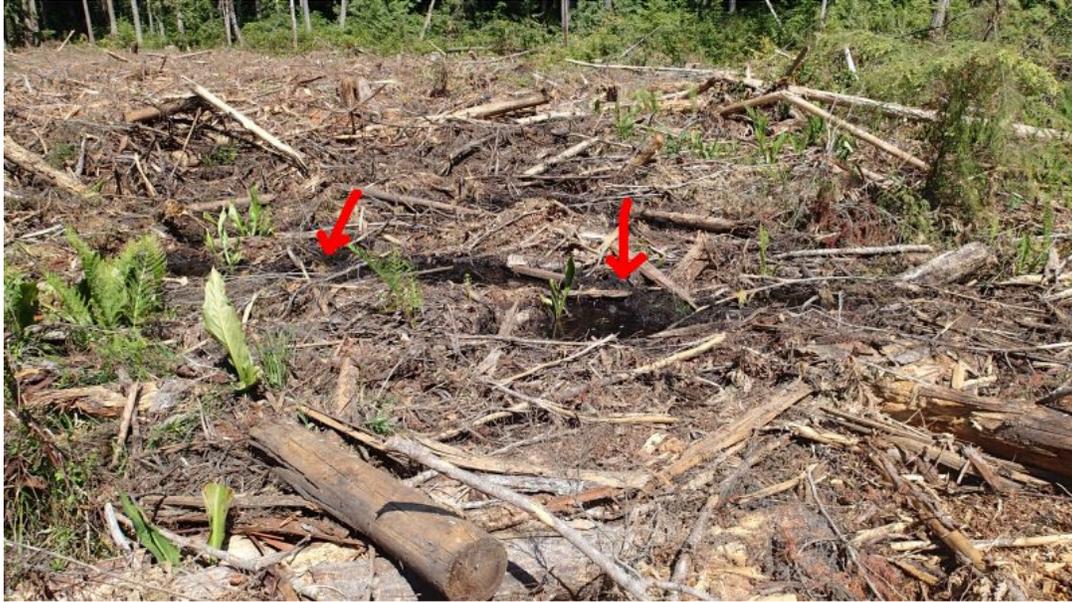
There was no evidence of sediment transport, or a deposit of other material to either McGuffie or McFall Creeks observed on June 15, 2015. The Logging Plan Map identifies a machine crossing of wet ground between FC93 and FC94 and specifies the use of puncheon (laying logs on ground) to minimize ground disturbance. This site was visited on June 15, 2015 (waypoint 571; Figure 5). The puncheon had been removed and minimal disturbance (skunk cabbage still present) of the wet ground was observed (photo 6). There was no evidence of, or potential for, sediment transport to Wys Creek.

Photo 6 Wet ground machine crossing near waypoint 571. Puncheon removed with minimal ground disturbance (skunk cabbage still present).

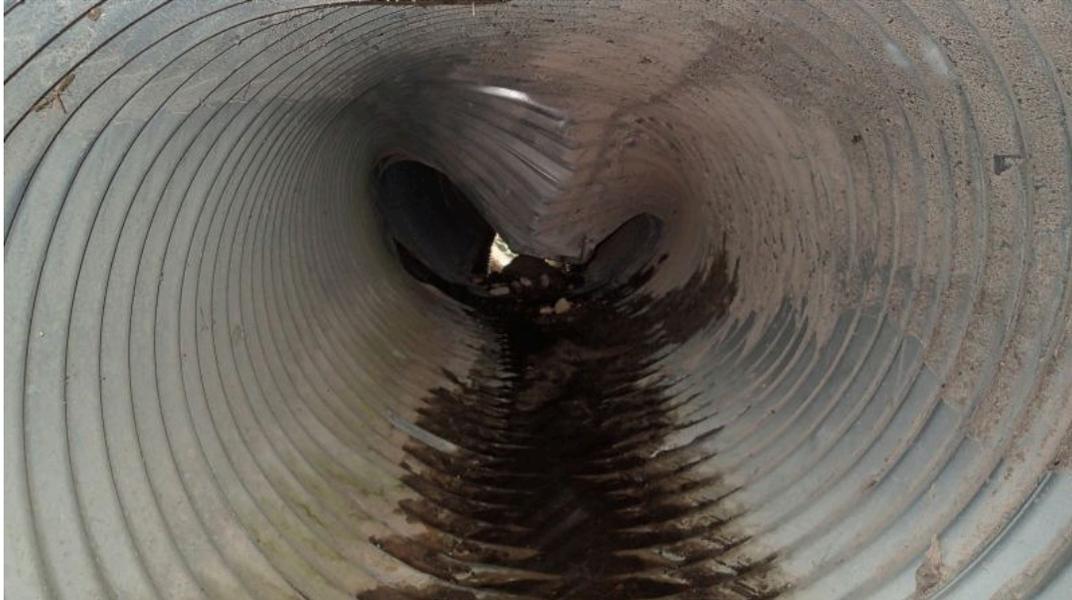
However, the culvert at waypoint 568 was significantly crushed approximately 2 m upstream of the culvert outlet during installation (photo 7) and the hydraulic capacity of this culvert has been significantly reduced. The culvert is now susceptible to being plugged with debris during high stream flows. It is therefore recommended that this culvert be replaced.

Photo 7Wys Creek culvert at waypoint 568. Hydraulic capacity significantly reduced and susceptible to plugging with debris.

Section 21 requires that roads and road drainage be maintained to the extent necessary to avoid a material adverse effect on fish habitat or on water diverted by a LWI. Roads were inspected on June 15, 2015 and there was no evidence that the road system would result in a material adverse effect as a result of a road maintenance issue. However, as stated in Section 1.2.3 of this report, it is recommended that the culvert at waypoint 568 be replaced.

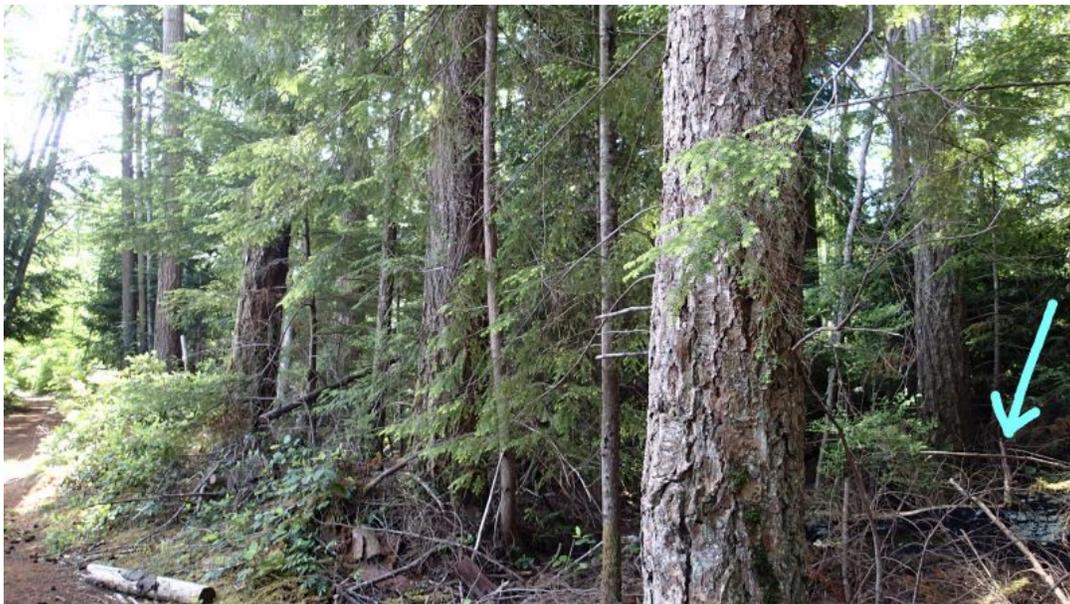
Riparian retention adjacent to McFall Creek could only be partially assessed since most of the area adjacent to this Creek had not been harvested as of June 15. Since a portion of the cutblock adjacent to McFall Creek had been harvested near FC30, a count of retained trees within the 10 m riparian zone adjacent to the creek was done at this location. Retained trees within 10 m of the stream that had diameters (dbh) greater than 30 cm were counted for a distance of 39 m (photo 8). The tree count was 30 trees in 39 m. Based on this initial count, riparian tree retention at this location significantly exceeds the PMFLCR minimum requirement of 25 trees per 100 m. However, as with McGuffie Creek, a final assessment of riparian management cannot be done until after forest harvesting has been completed.

Photo 8 Looking at the riparian area adjacent to McFall Creek. 30 large trees retained in a 39m long section of McFall Creek. Blue arrow shows the approximate location of the creek which is flowing roughly parallel to a recreational trail (trail is in the lower left corner of image).

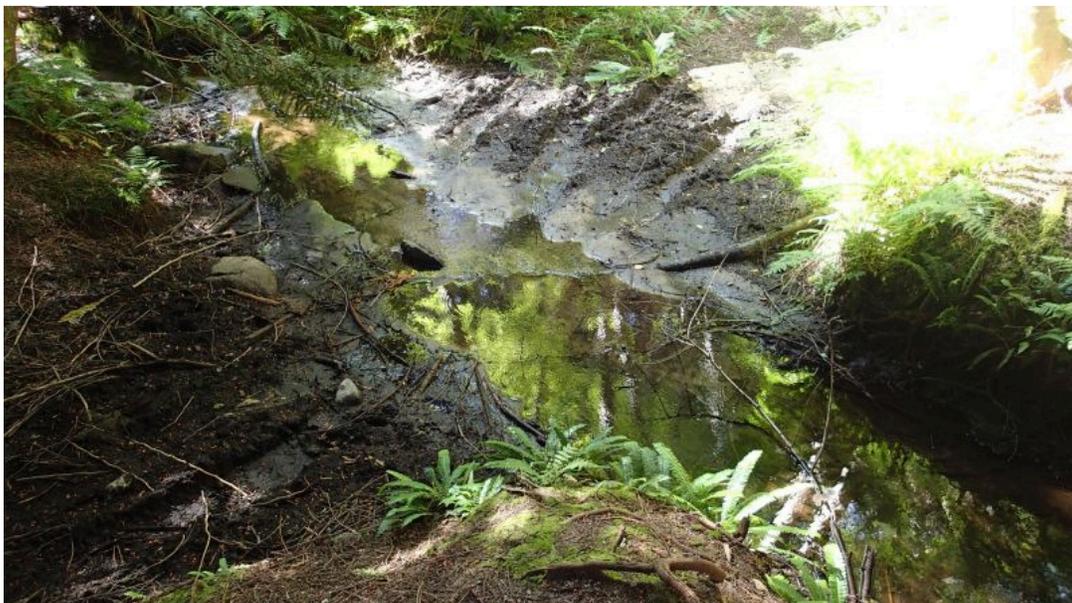
The location of the wheel tracks through the stream was found on McFall Creek at waypoint 573 (Figure 4). The distance between these wheel tracks was measured at 90 cm (photo 9) indicating the rutting was due to a small vehicle such as a quad. This crossing is also well outside of the forest harvesting that had occurred as of June 15, 2015. The crossing at waypoint 573 is located on a recreation trail that could not be accessed by logging equipment without the clearing of vegetation to widen the trail.

Photo 9 McFall Creek at recreational trail at waypoint 573. Wheel ruts caused by quads (90 cm between ruts).

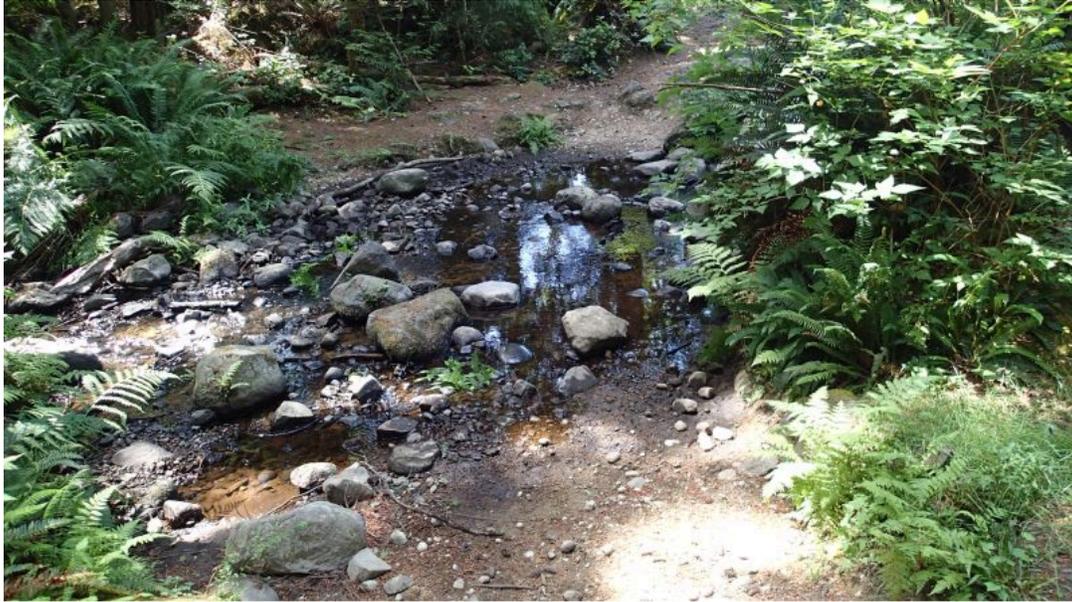
A second trail crossing was found on McFall Creek near waypoint 567 (photo 10). This crossing is also located on a recreational trail and is likely crossed with quads on occasion. There was no evidence that McFall Creek, or either McGuffie or Wys Creeks, had been crossed by logging equipment.

Photo 10 McFall Creek at recreational trail at waypoint 567. Numerous juvenile coho observed at this location.
