MANAGED FOREST COUNCIL

Review of Soil Conservation Events related to Forest Management
Activities within the Comox Lake Watershed

November 2015

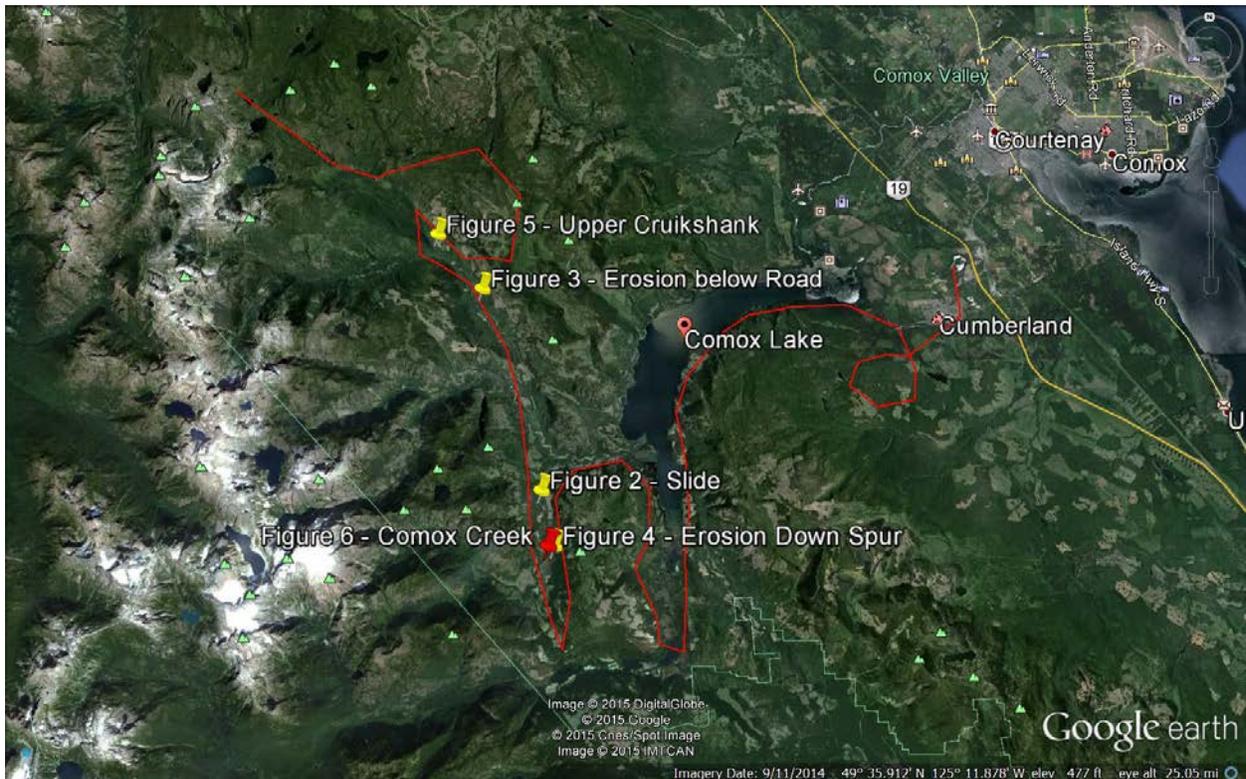
Figure 1 – February 17, 2015 flight path

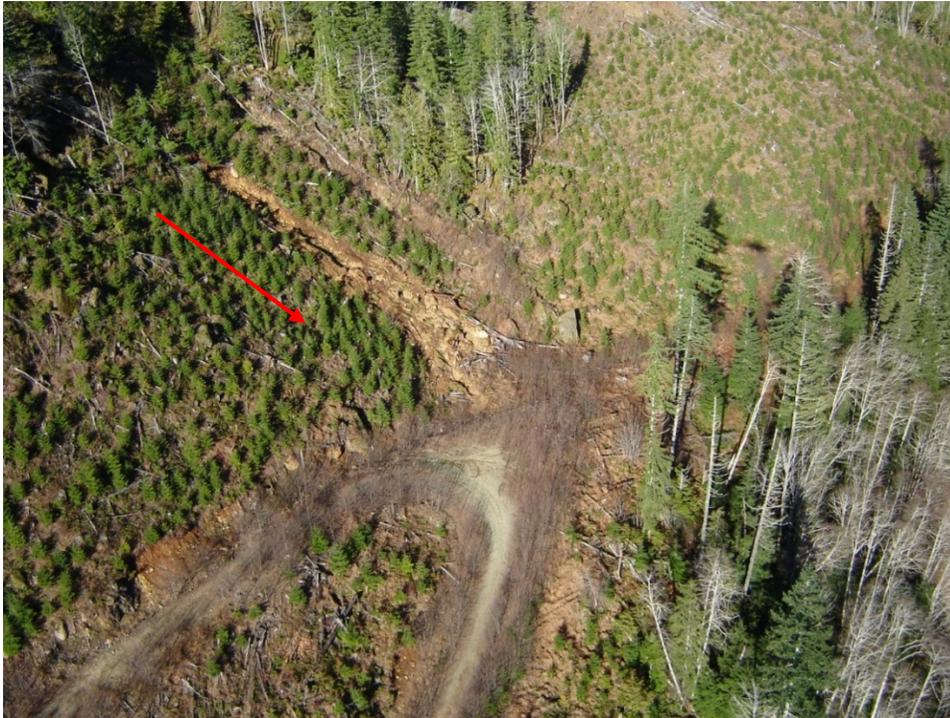
Figure 2 – An example of a small slide / failure initiated within a cut block that was deposited on the corner of a switchback. No material from this failure entered a creek.

These three events would be considered insignificant based on their location within the watershed, their scale and size, and lack of evidence of material from the events reaching waterbodies. Based on the overview flight in the watershed it was concluded there was no evidence of mass wasting events associated with ongoing forest management activities in the watershed that could have contributed in any significant way to the boil water advisory issued by the CVRD on December 11, 2014. Our observations did not identify any instances of non-compliance with the Regulation.

Figure 2- Small slide associated with a harvested area, undated event

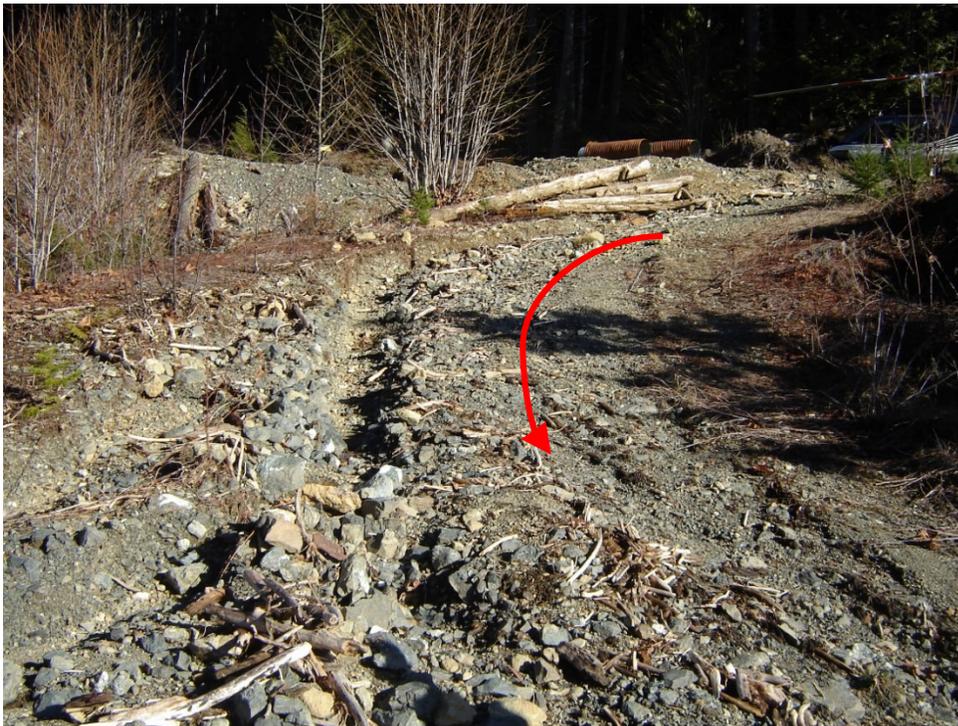
Figure 3 – An event associated with water running down an old access road below the existing mainline that deposited eroded material at the bottom of the spur. It did not appear material from this event had entered a creek.

Figure 3 – Erosion from the effects of water running downhill off the road surface in the upper portion of the picture, undated event

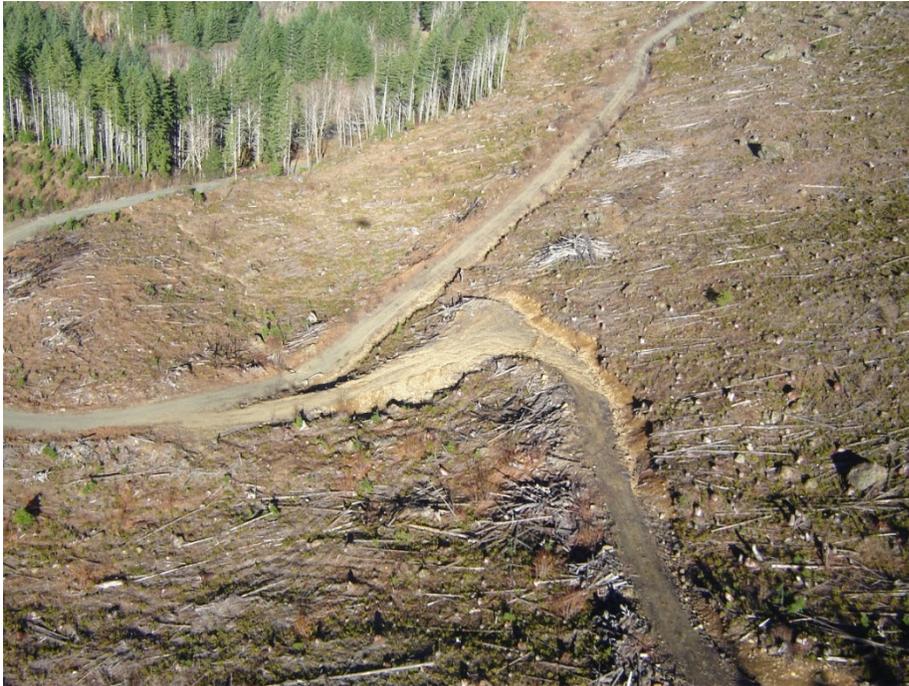
Figure 4- Erosion of soil down a spur road from water coming down a bank through a logged area. It did not appear any material had entered a creek.

Figure 4 – Soil movement down a spur road in a harvested area, undated event

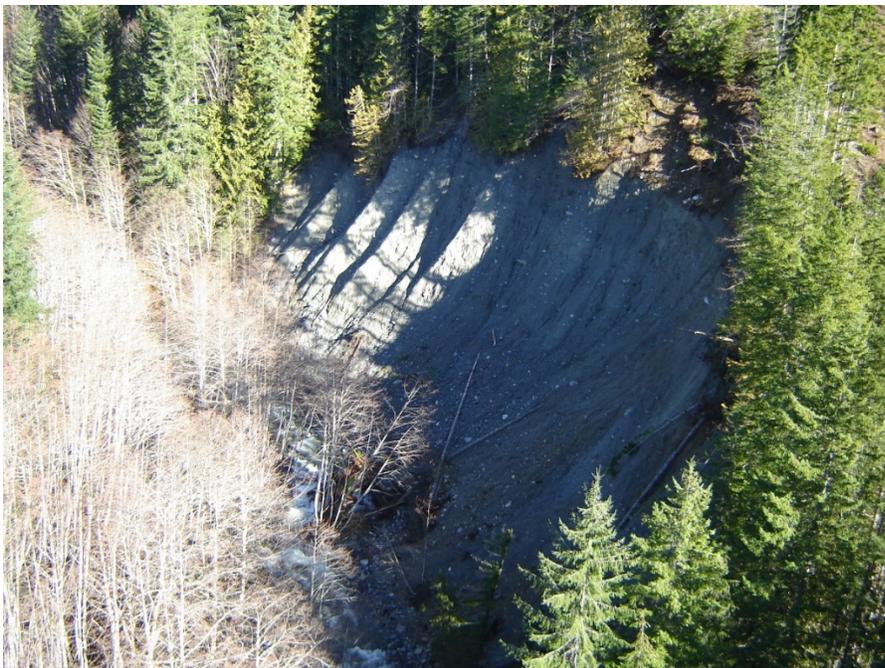
The review of erosion from natural sources was outside the scope of the reconnaissance level review. Natural sources of erosion represent areas of erosion that would occur regardless of the presence of forest management activity in the area. During the flight two small naturally eroding areas were reviewed, one along the Upper Cruickshank River (Figure 5) and one on Comox Creek (Figure 6). Both these areas have been known to exist for many years. During our review it did not appear these two areas had recently contributed a significant volume of bedload material to either of the two creeks.

Figure 5 – Natural bank erosion along the Upper Cruickshank River, February 17, 2015

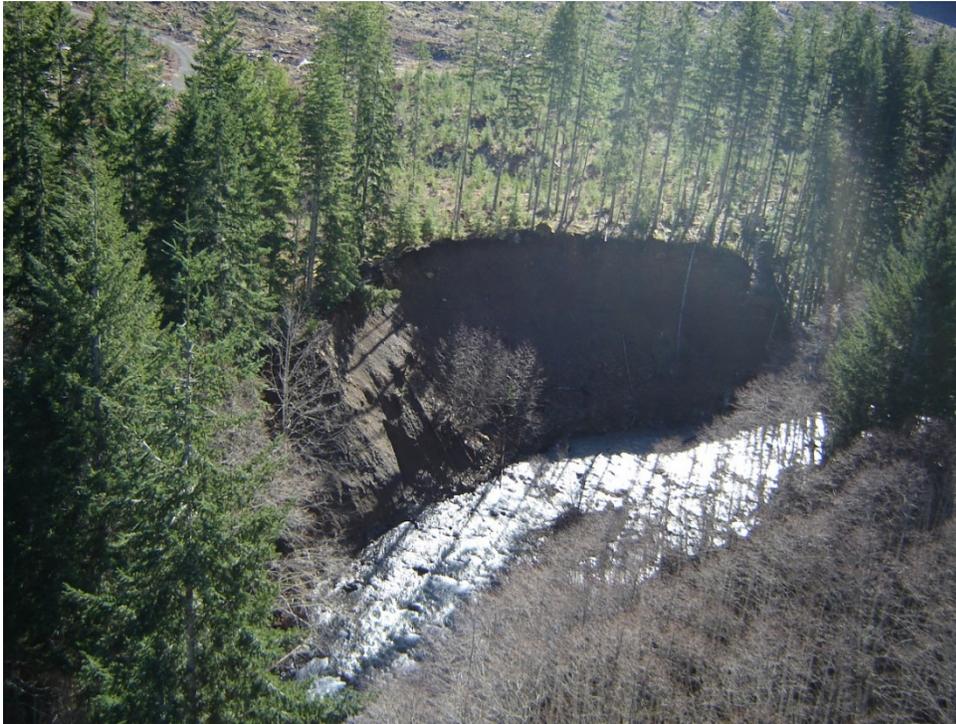
Figure 6 – Natural bank erosion along Comox Creek, February 17, 2015

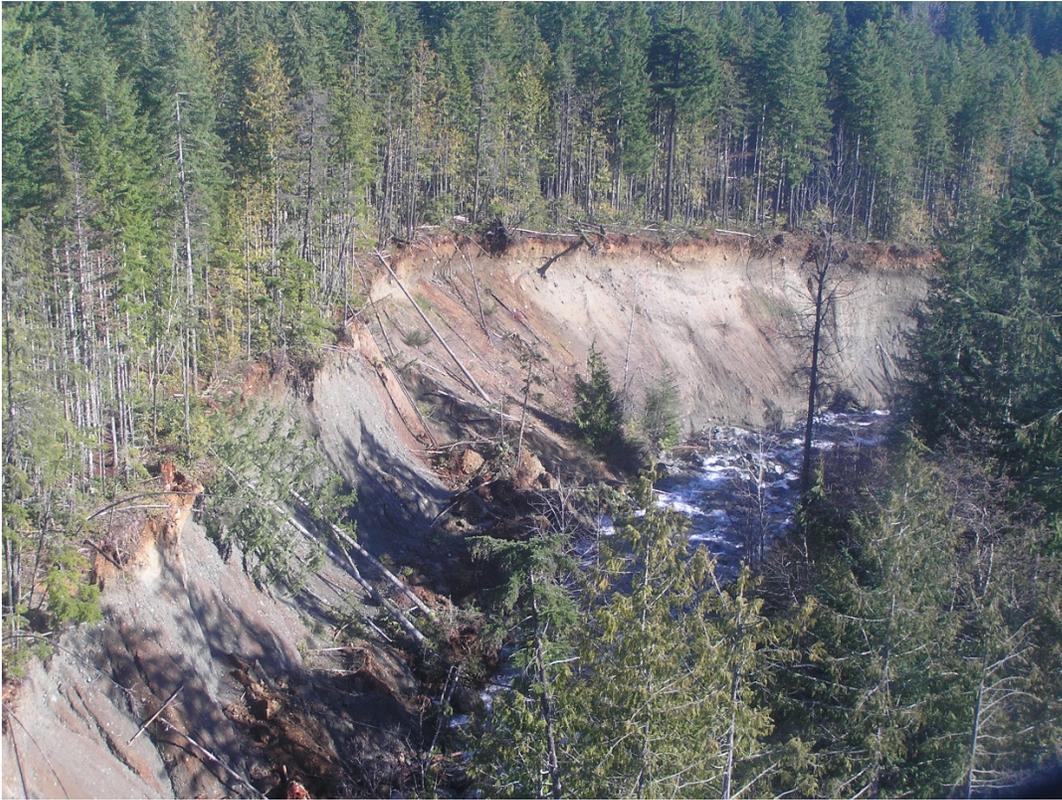
Throughout this review an issue involving the Cumberland water supply was pointed to by the various stakeholders with whom we talked as a possible source of the turbidity that led to the extended boil water advisory issued by the CVRD and Island Health. The issue is with what's known as the Henderson Lake portion of the Cumberland water supply. More specifically, Cumberland Lake or Lake #2 which is in a string of four lakes that make up this portion of the water supply. The other portion of the Cumberland water supply comes from Allen Lake. The issue as described in various reports and studies is that water from Cumberland Lake is diverted out the back of this reservoir down a spillway during high flow events. When this occurs the potential exists for significant erosion to occur down the ravine behind Cumberland Lake with water and eroded material eventually reaching Perseverance Creek. The mouth of Perseverance Creek is approximately 2.2 kilometers from the start of the Puntledge River. The intake of the Regional District water supply is 3.7 km downstream. The storm events that occurred in December 2014 (1 in 50 year event) in all likelihood resulted in large volumes of water moving down the spillway of Cumberland Lake with the subsequent movement of eroded material down the ravine into Perseverance Creek. Our flight on February 17, 2015 confirmed the ravine behind Cumberland Lake was actively eroding (Figures 7 and 8). What is important to note is that the extent of erosion occurring in this ravine was not encountered at any other location in the watershed during our flight. Although not conclusive, in all likelihood the eroded material from this location played a significant role in the elevated turbidity levels which resulted in the CVRD issuing a boil water advisory in December 2014 and the subsequent abatement order issued by Island Health on August 7, 2015 to the various stakeholders.

Figure 7 – Active bank erosion along ravine behind and below Cumberland Lake, Feb 17, 2015

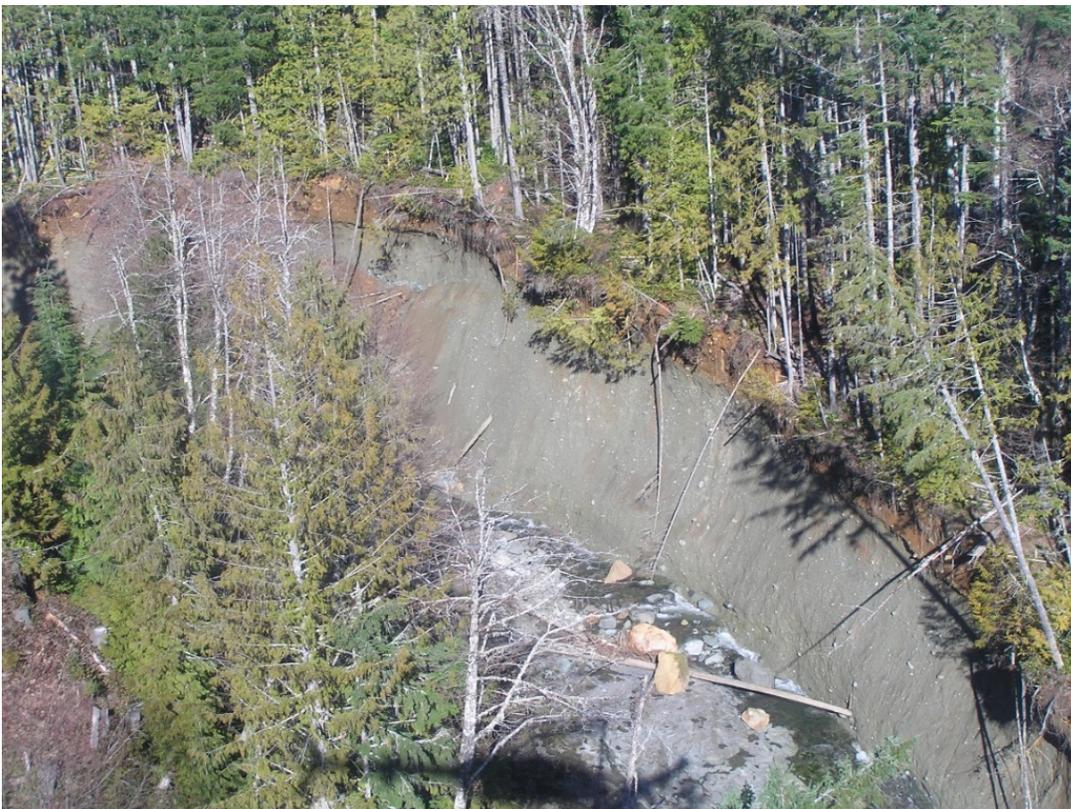
Figure 8 – Over steepened bank of ravine behind and below Cumberland Lake, February, 17, 2015
